ΣΥΜΦΩΝΑ ΜΕ ΤΟ ΠΡΟΤΥΠΟ NF C 17-102

TEST REPORT

Nº LRIC-IE14-2-2

DATE OF ISSUE:	06/11/2014
TESTING LABORATORY:	Lightning Research Institute of Catalonia
APPLICANT'S NAME:	Cirprotec, S.L. C/ Lepanto, 49 · 08223 · Terrassa (Barcelona) · Spain
TEST SPECIFICATION	
TEST:	Current test to 200kA
TEST METHODOLOGY:	UNE 21186: Protección contra el rayo: Pararrayos con dispositivo de cebado (2011). NF C 17-102: Protection contre la foudre: Systèmes de protection contre la foudre à dispositif d'amorçage (2011) PRLAB17 version 3.0.
OBJECT UNDER TEST	
TRADE MARK:	CPT
MANUFACTURER:	Cirprotec, S.L. C/ Lepanto, 49 · 08223 · Terrassa (Barcelona) · Spain
MODEL:	Nimbus 60 (complete description see page 2).

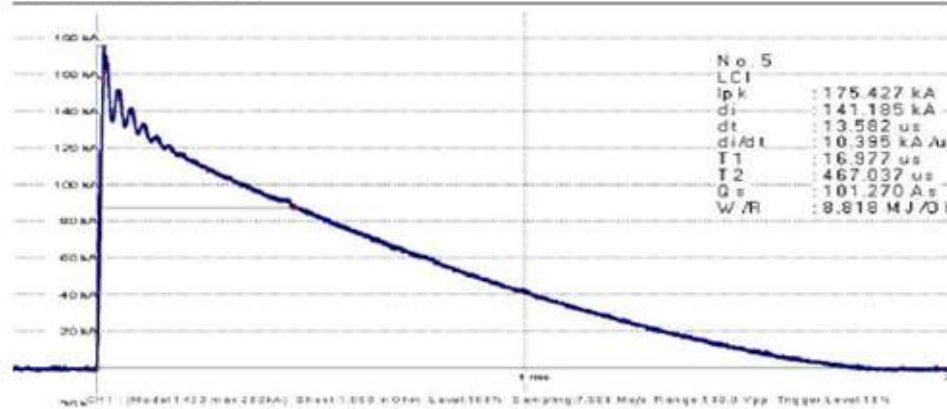
Figure 7.1.1. Current impulse to 200kA applied to the sample

LRIC-IE14-2/1		
	I_{peak} (kA)	Q (A-s)	W/R (kJ/Ω)
Real	175	101	8818
Standard	200	100	10000
CC (%)	-12%	1%	-11%

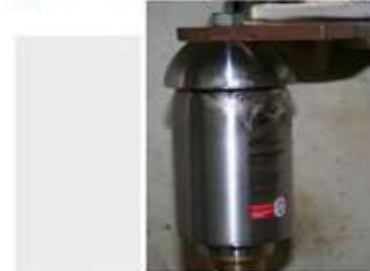
Figure 7.1.2. State of the sample after the current test

PASS CRITERIA	RESULT
The current recording doesn't reveal any indication of deterioration or perforation of the sample.	PASS
The visual inspection don't reveal any indication of deteriorations or perforation excepts the part that drain off the lightning current where traces of emissions and superficial fusion can appear.	PASS
The LR TESTER shows that the device is working properly after testing (PASS).	PASS

The sample has been submitted to one impulse to 200kA without showing any signal of damage or perforations of the sample, except the parts that drain off the lightning current where appear traces of emission and superficial fusion. After that, the device has been checked with the LR-TESTER with satisfactory results.

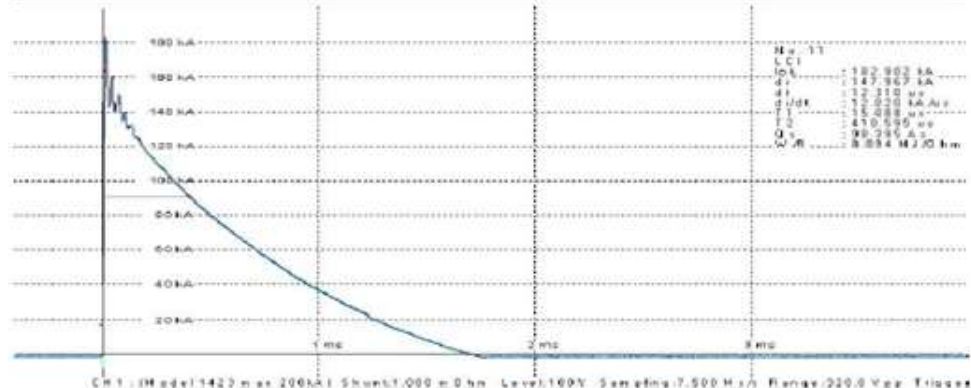
Figure 7.1.1. Current impulse to 200kA applied to the sample

LRIC-IE13-80/1			
	I_{peak} (kA)	Q (A·s)	W/R (kJ/Ω)
Real	182.90	98.40	8894
Standard	200.00	100.00	10000
CC (%)	-8.55%	-1.61%	-11%

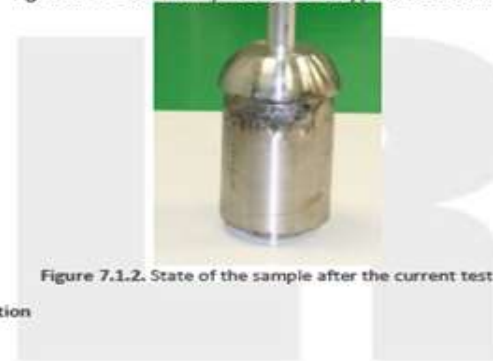
Figure 7.1.2. State of the sample after the current test

PASS CRITERIA	RESULT
The current recording doesn't reveal any indication of deterioration or perforation of the sample.	PASS
The visual inspection don't reveal any indication of deteriorations or perforation excepts the part that drain off the lightning current where traces of emissions and superficial fusion can appear.	PASS
The LR TESTER shows that the device is working properly after testing (PASS).	PASS
